EXPLOSIVE FORMING OF M-1 HELMETS

Ryan Aeronautical Company

Contract DA19-129-QM-1540

24 July 1961

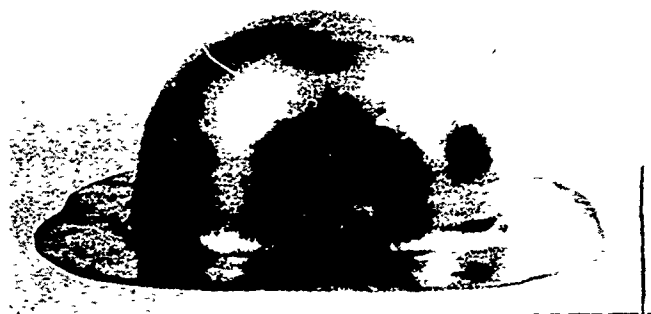
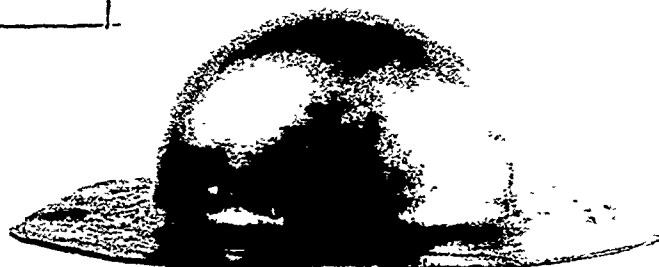
Figure 27. Helmet at End of First Stage Forming

FULLY FORMED IN FIRST
STAGE DIE.

FLANGE TRIMMED AND
MATERIAL ADDED TO
HOLD VACUUM.

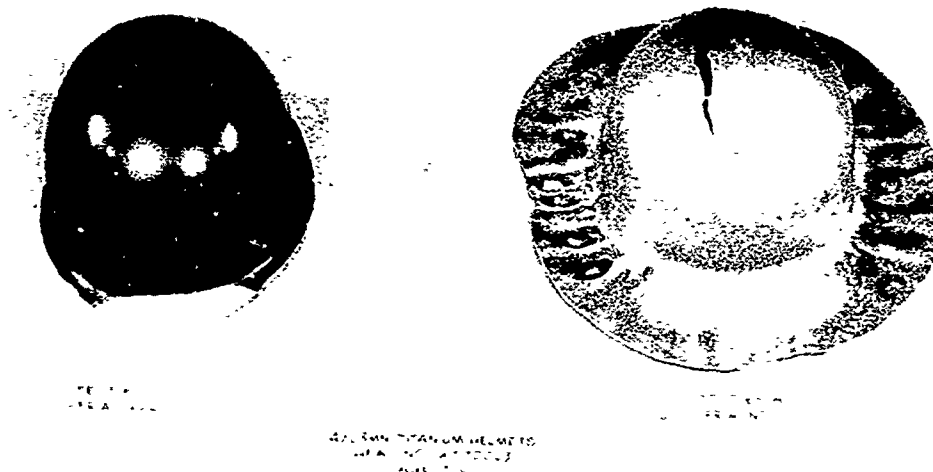
Figure 37. Tests 651, 651A

1. Test No. 651 - Formed and trimmed helmet complete and sprayed with protective coating.
2. Test No. 651A - Fracture caused by material work hardening and/or too great a clamping pressure.
